Manhole Inspection Summary

Manhole # S29CC1044MH

Location Address: **3730 CRAYCOMBE AVE**

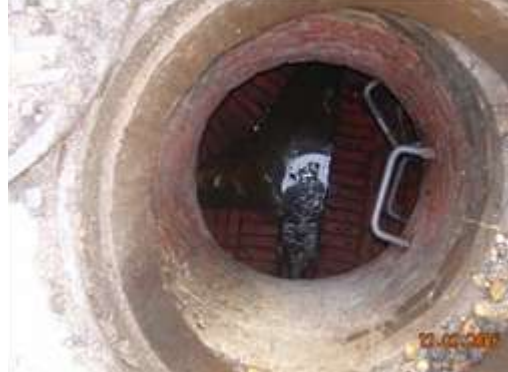
Top View

Frame leaks. Frame offset. Adjustment deterioration and infiltration. Channel debris.

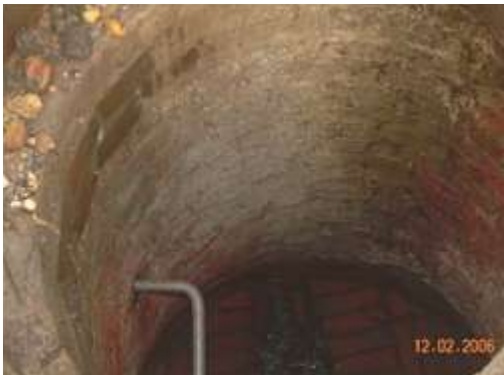
Defect

Frame offset. Adjustment, Corbel and Barrel infiltration.

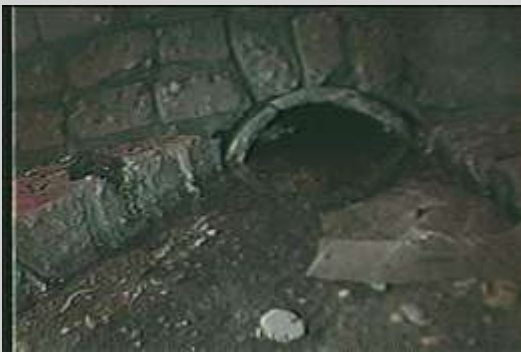
8 in. Circular Gravity Sewer Pipe Out @ 12 O'Clock

Deposits: ☐ None ☒ **Mud** ☐ Sludge ☒ **Debris** ☐ Grease

Silt Depth: **5** (in.) Deposits Extent: **Heavy**

Infiltration: **Evidence** Pipe Seal Cond: **Cracked**

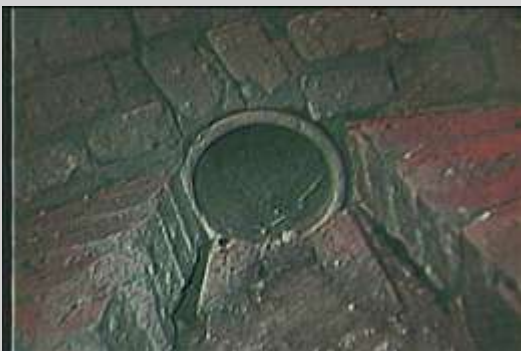
8 in. Circular Gravity Sewer Pipe In @ 6 O'Clock

Barrel deterioration and infiltration. Channel deterioration.

Infiltration: **None** Pipe Seal Cond: **Cracked**

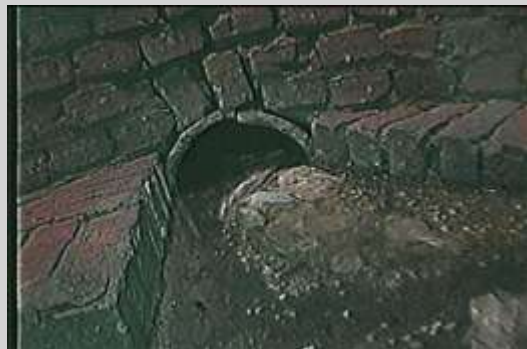
Pipe In @ 9 O'Clock

Barrel deterioration and infiltration.

Deposits: ☐ None ☒ **Mud** ☐ Sludge ☒ **Debris** ☐ Grease

Deposits Extent: **Heavy**

Infiltration: **Evidence**

Pipe Seal Cond: **Broken**
